Building Inspection Report

SAMPLE REPORT

Type of Inspection : Full Written Inspection + Leak Detection Report

Property Description : Dwelling is a single level polystyrene and weatherboard –clad three bed home sited on a slightly sloping residential section

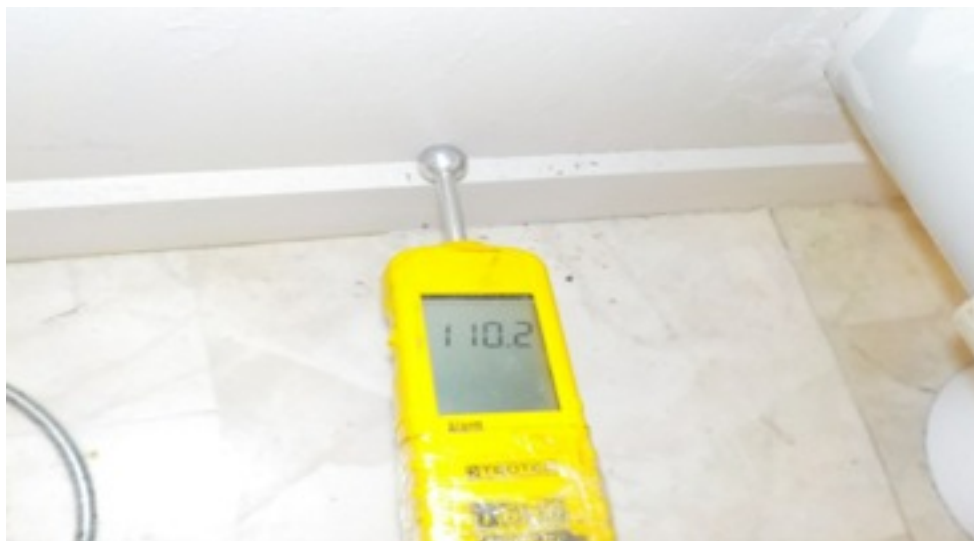
THERE WERE NO ELEVATED MOISTURE READINGS TAKEN DURING LEAK DETECTION SURVEY TO EXTERIOR WALLS OF HOME, APART FROM MINOR LEAK AT BACK OF TOILET – PROBABLY FROM LEAKING OVERFLOW PIPE. .

Figure 1: MINOR LEAK BEHIND TOILET, RECOMMEND FURTHER INVESTIGATION AND REPLACEMENT OF TOILET IF NECESSARY.

Toilet		X	X	Possible leak from overflow pipe
Walls		X	X	Leak from toilet needs repair , may be easier to replace whole toilet.
Floor				
Trim				
Door/lock				
other

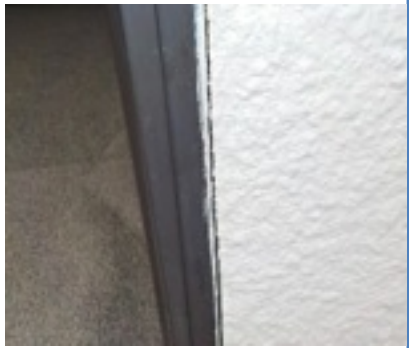
Image 1

Items/Components	OK	Not Ok	Requires Further Investigation	Comments / Follow Up
<i>Polystyrene</i>		X		Side of ranchslider at front deck needs re-sealing to maintain weathertightness . image 1
<i>Fibre -cements Soffits</i>				
<i>Other wall cover</i>		X		Cedar weatherboards to bay window area requires scribes fitted to sides of windows . Image 2
<i>Ground cover</i>				
<i>Walkway</i>				
<i>Driveway</i>				
<i>Porch</i>				
<i>Porch stairs</i>				
<i>Deck</i>				
<i>Deck stairs</i>				
<i>Stairs</i>				
<i>Gutters and downspouts</i>				
<i>Exterior lights</i>				
<i>Garage</i>				
<i>Other</i>

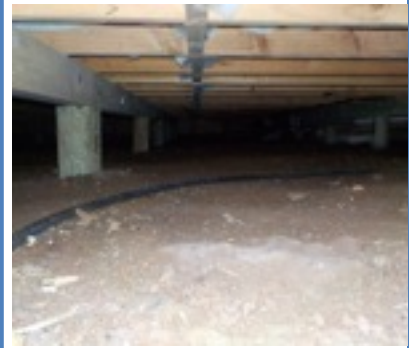
Figure 2:subfloor is in good condition and is insulated and dry.
